NASA/TM-2008-215100
NESC-RP-06-115/06-028-E

International Space Station (ISS) S-Band Corona Discharge Anomaly Consultation

NASA Engineering and Safety Center Technical Consultation Report	Document #: RP-06-115	Version: 1.0
Title: ISS S-Band Corona Discharge Anomaly Consultation			Page #: 1 of 26

December 14, 2006

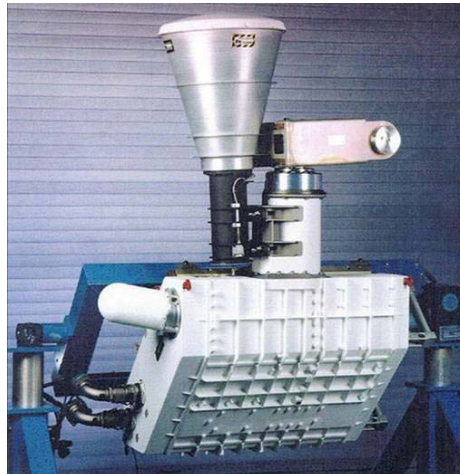
Figure 6.1-1. S-Band Assembly Contingency RF Group (ref. 5)

On April 13, 2006, there was a reflected RF power anomaly observed after four minutes nominal operation within the ACRFG (refer to Figure 6.1-1). This was in the “String 1 RFG” unit on S1 (S/N 002) as shown on the ISS in Figure 6.1-2. The “String 2 RFG” unit (S/N 003) on P6 is the primary unit. The spare unit (S/N 001) is stowed on Z1. Corona was examined as a possible root cause of the anomaly. Section 3.5 of the MDA ACRFG Reflected RF Power Anomaly Report (ref. 1) determined the necessary voltages to produce corona, at various pressures, in the narrowest electrode gaps in the coaxial cavity 5-pole diplexer and 3-pole bandpass filter (see Figure 6.1-3) assemblies. The results of the MDA analysis suggest the conditions present in the Bandpass Filter and Diplexer at 1 psia may have been favorable for the corona.

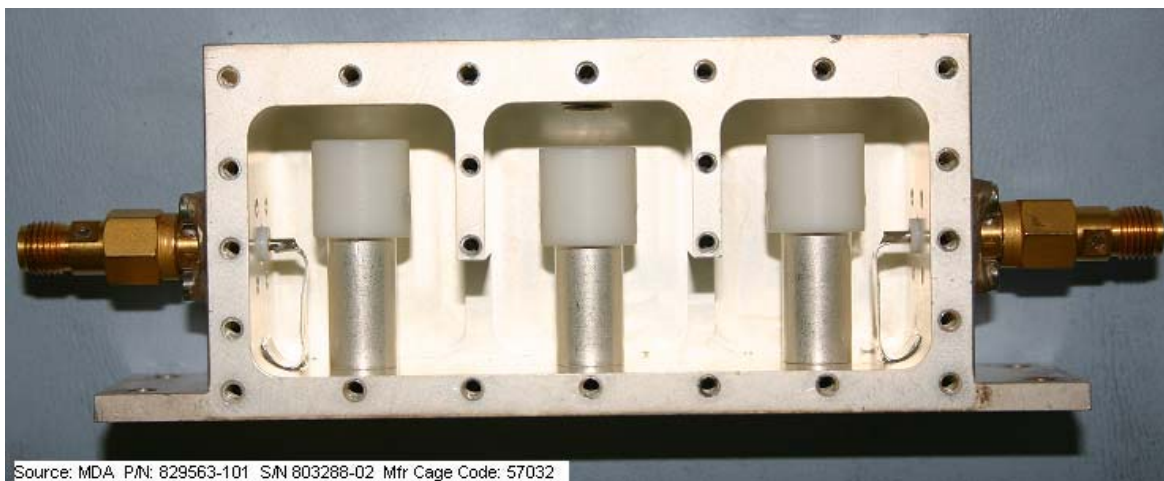
Figure 6.1-3. Bandpass Filter Assembly (ref. 5)

Section 3.5 of the MDA report determined the necessary voltages to produce corona, at various pressures, in the narrowest electrode gaps present in the subassemblies. As shown, the conditions present in the three pole Band Pass Filter and Diplexer at 1 psia may have been

favorable for corona. However, corona as a cause was judged unlikely because of the observed on-orbit conditions of four minutes normal operation and then degraded operation. The end of Section 3.5 states “Corona tends to be a violent occurrence and with permanent damage. Continued operation would not be sustained.”

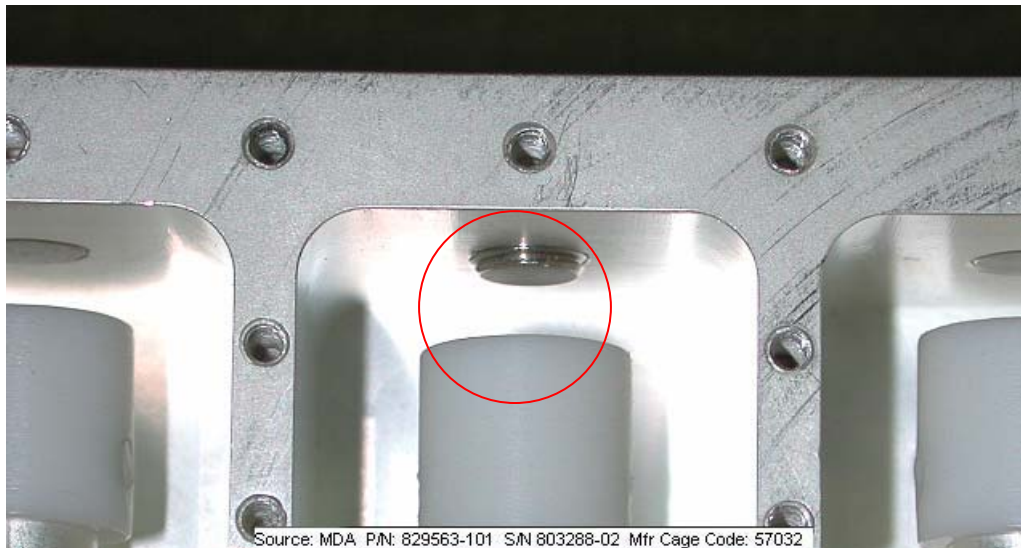
Figure 6.1-4. Bandpass Filter Tuning Screw and Gap (ref. 5)

However, corona was judged unlikely in the initial MDA report because of the observed on-orbit condition of four minutes of normal operation followed by degraded service. The end of Section 3.5 (ref. 1) states: "Corona events tend to be a violent occurrence and with permanent damage. Continued operation would not be sustained." For these reasons, a solder joint at the input to the bandpass filter was initially identified by MDA as the most likely proximate cause of the on-orbit ACRFG anomaly.

The MDA report had concluded that a solder joint failure at the input of the bandpass filter was the most likely proximate cause of the on-orbit anomaly. The NESC Team noted that it is

possible that corona inside the filter cavity could erode (or more likely melt open) the solder connection attaching the injection loop's end to the case-wall, leading to a separation and result in observed signal loss. If the solder melted, or even reached the softening temperature, then the residual stresses in the loop (shown in Figure 3.2-2, page 16 of the MDA report) could allow separation. This hypothetical detachment would also drop the voltage level in the cavity below the value needed to sustain the corona, at least for the present pressure. If this solder connection separation has happened, then there can be no further corona until the pressure decreases enough to move the system far enough along the Paschen curve so that the plasma threshold drops to the now-available voltage level. The predicted time for this change in plasma threshold could be approximated from the measured leak rate and the Paschen curve for N_2 .

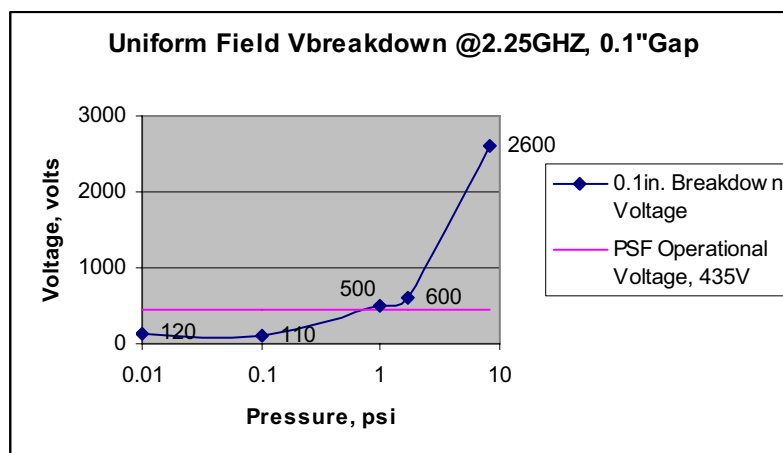
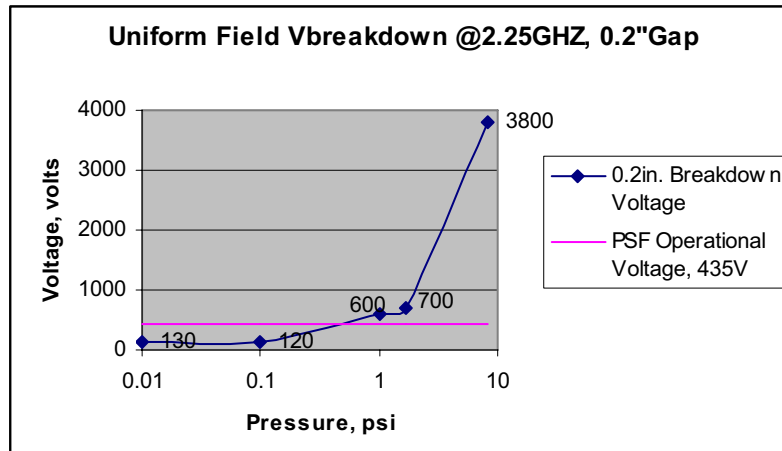
Figure 7.2-1. Breakdown Voltage versus Pressure for Various Gaps (in air) from Woo Curves (ref. 6)

The charts in Figure 7.2-1 show the RF breakdown voltages for a range of pressures in an air environment (refs. 5 and 6). For the purposes of this analysis, N₂ and air are considered

1. At pressures between 0.001 psia and 1 psia, corona is almost certain (>90 percent) for the gap sizes within these assemblies (>90 percent).
2. At pressures of greater than 2 psia, corona at any gap size is unlikely (<10 percent).
3. Between 0.1 and 1 psia, the margin between the operating voltage and corona inception level is essentially non-existent, and the likelihood of corona should be moderate (~70 percent).
4. Below approximately 0.001 psia, multipactor breakdown dominates over ionization breakdown. Corona does not occur in hard vacuum (e.g. <0.00001 psia). However, multipactor breakdown is still possible for small gaps (0.1 inch) in this pressure region, so a breakdown probability of 50 percent would be appropriate.

In the 1 to 2 psia region, the probability of corona is undefined. This is the “knee” of the Paschen curve where the breakdown voltage characteristic changes greatly with small changes in pressure.
